Ruins Stabilization in the Southwestern United States

RUINS STABILIZATION IN THE SOUTHWESTERN UNITED STATES

**ROLAND VON S. RICHERT and
R. GORDON VIVIAN**

National Park Service
U. S. Department of the Interior
Washington 1974

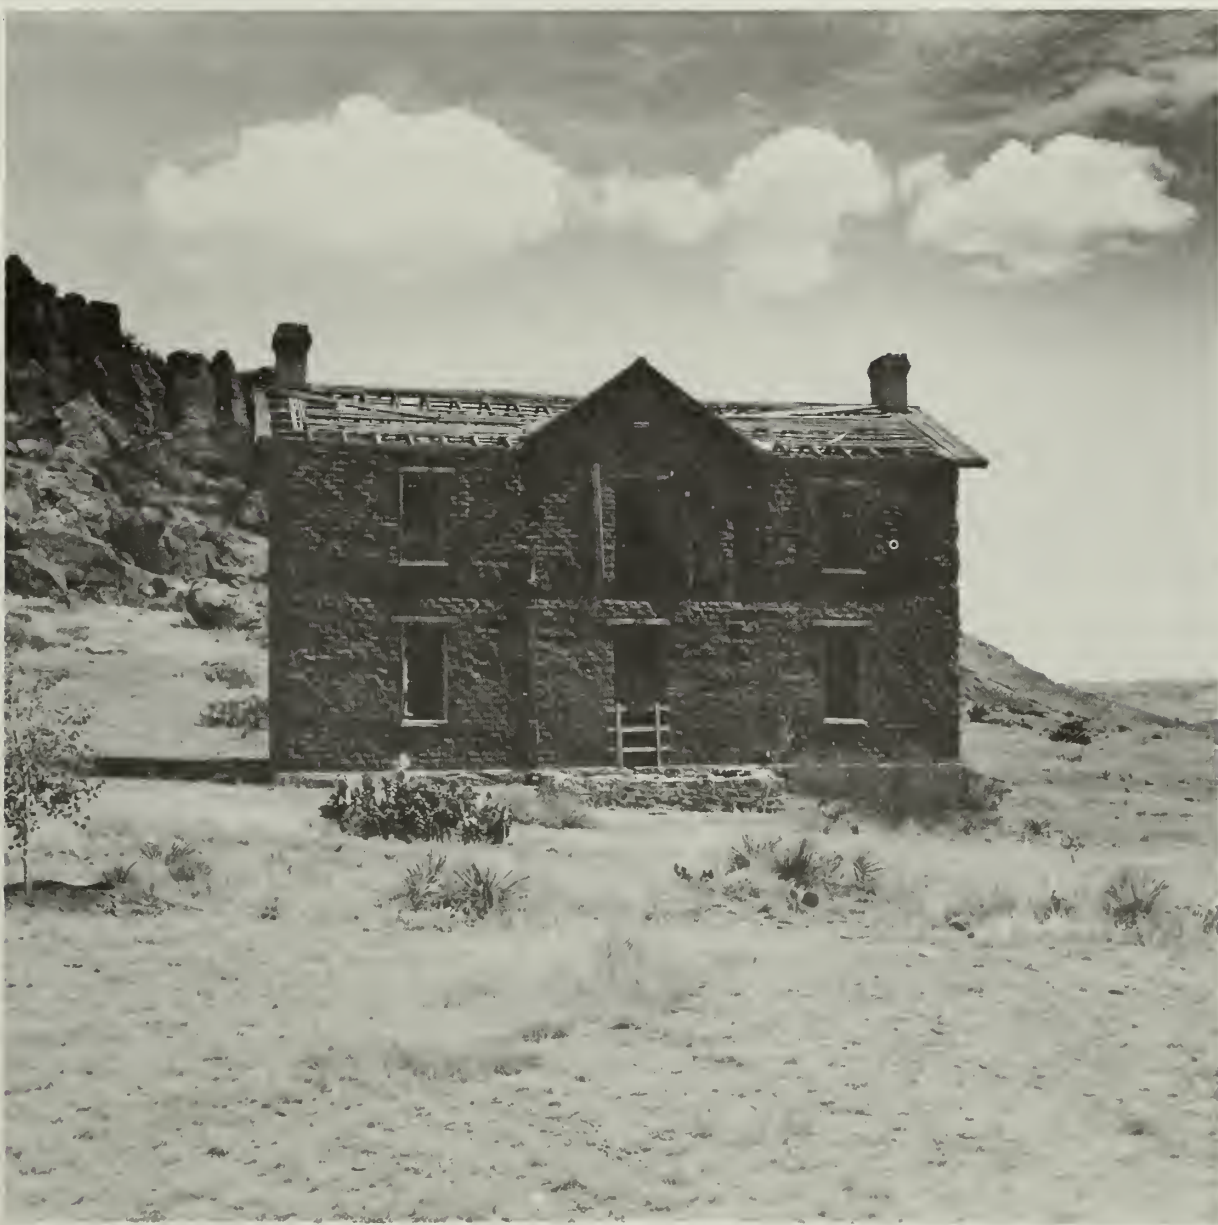
FIGURE 58. Building HB-15, a non-commissioned officers quarters at Fort Davis National Historic Site, before combined stabilization and modified restoration work was accomplished by the National Park Service.

This construction restored the exteriors of two 2-story buildings to their original appearance. The tops of the walls, weakened by erosion, were rebuilt and capped with reinforced concrete-bearing beams to support new roofs. Where exterior faces of adobe walls were severely weathered, a masonry veneer was added to rebuild the wall section to its original thickness using soil-cement units colored and textured to match the existing adobes. New wood porches were added to the exterior entrances, and doors and windows restored to the openings to secure the buildings. Thus the structures are interpreted as part of the historic scene. A self-guiding trail provides access and supplies necessary for interpretation.

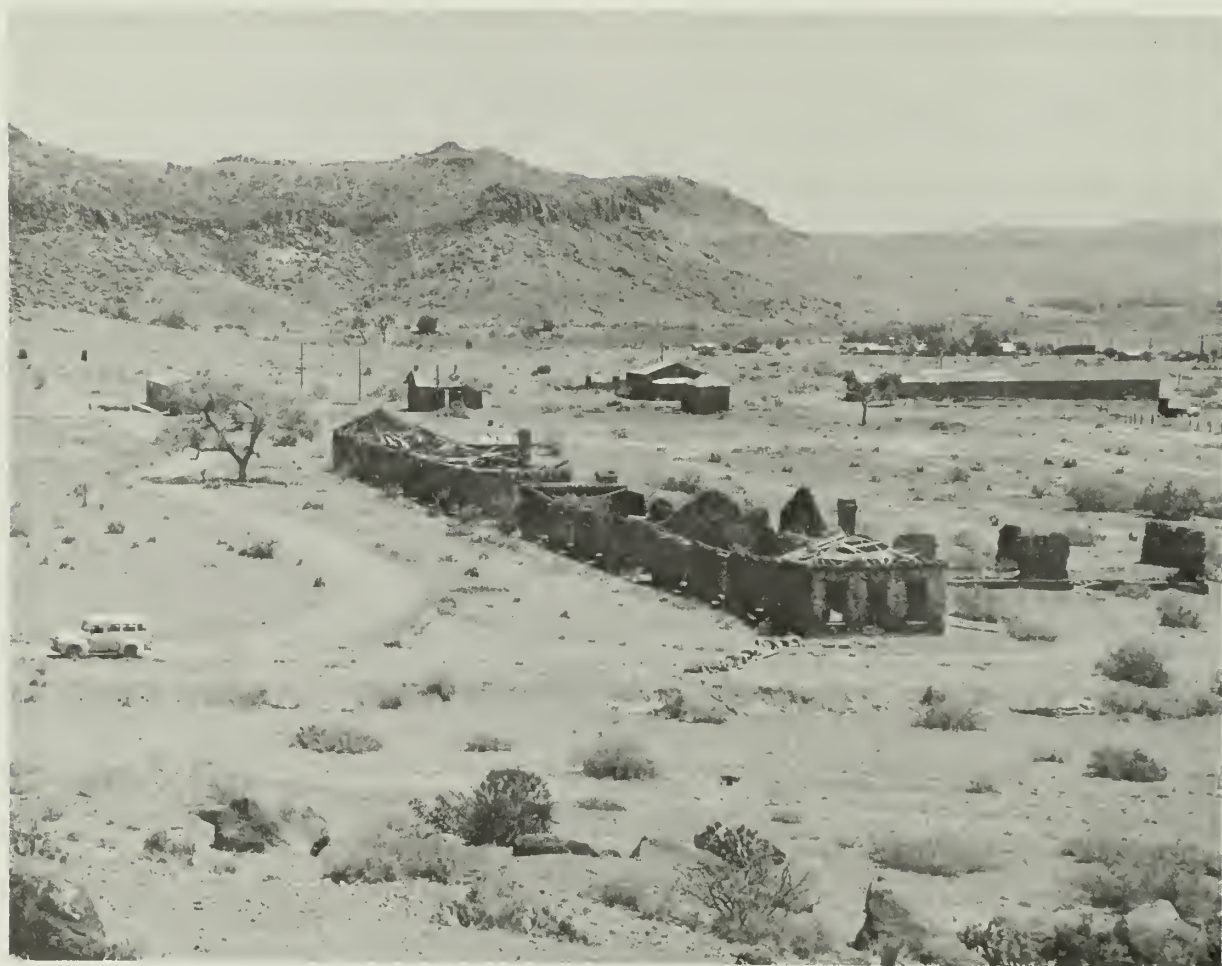
FIGURE 60. The 1870 enlisted men's barracks (in right foreground), Fort Davis National Historic Site. The photo was taken in 1960, before National Park Service status. Historic documents, drawings, and photographs provided ample evidence on which to base a restoration.

The visitor center at Fort Davis is an adaptive restoration. The 1870 enlisted men's barracks, which was a roofless, ruinous shell in 1964, was left virtually intact and a modern veneer of soil-cement bricks built around it. Some sections of original adobe walls were pared down so that the veneer would make up the original width. Bearing beams and integral support were provided for the modern though authentic roof. The restored portion of the exterior was faithfully preserved in both form and detail, while the interior was converted to modern, functional use (figs. 60 and 61). A small, glass-enclosed framework on the interior of the restored barracks shows an original portion of adobe wall for viewing by visitors.

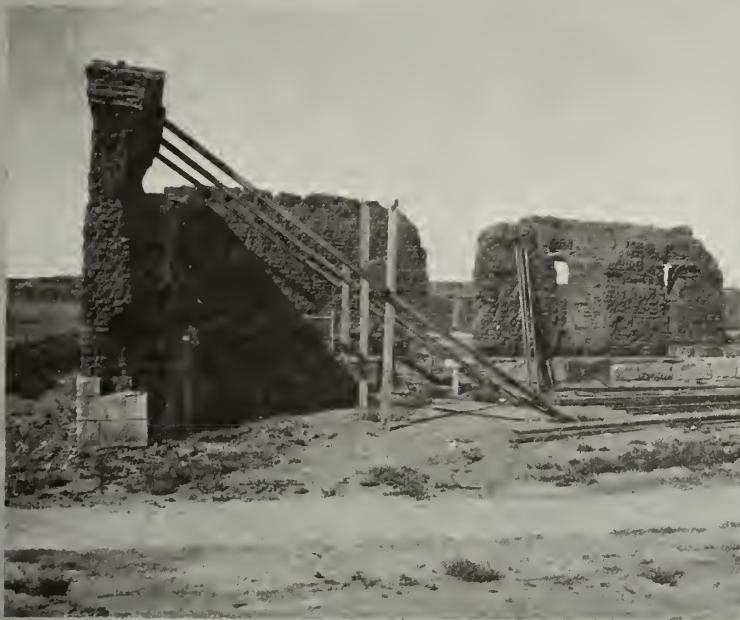
BUILDING 3-330,
ROOM 331,
WING WALL,
BEFORE
STABILIZATION

FIGURE 64. All ruins stabilization records should include before and after pictures attached to separate sheets such as the ones above for Fort Union National Monument.

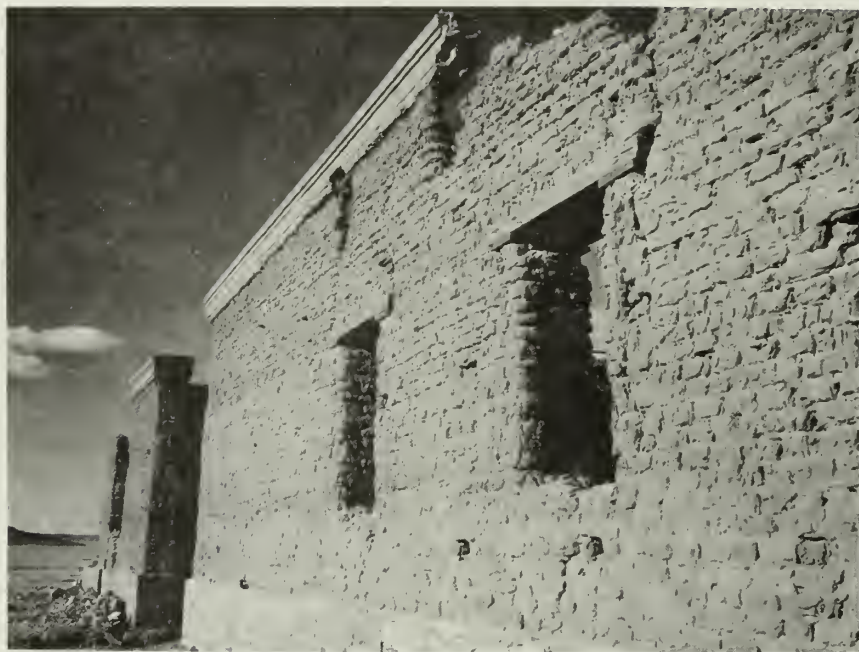
FIGURE 65. Building 3-450 (left) and building 3-440, west walls and coping, before stabilization. Fort Union National Monument.

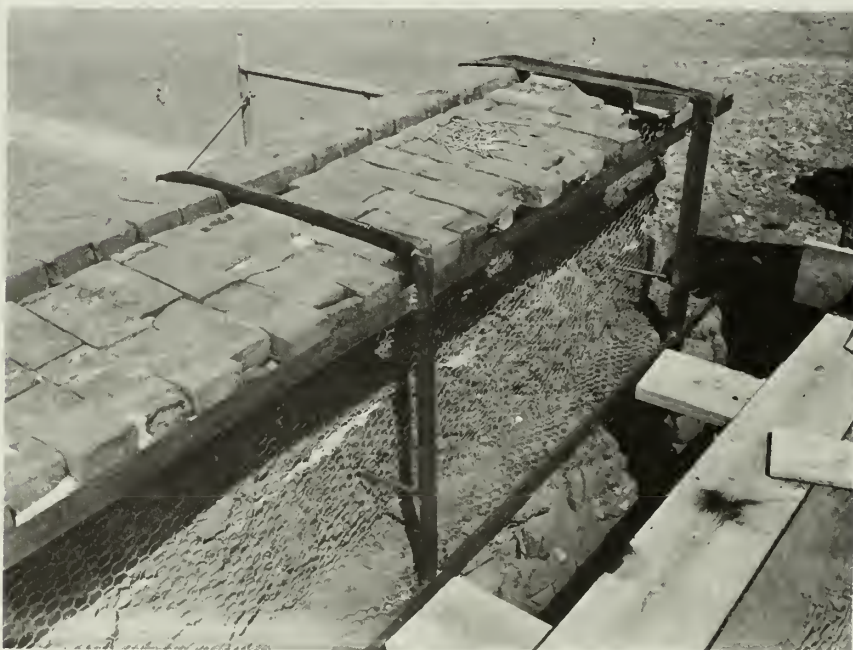
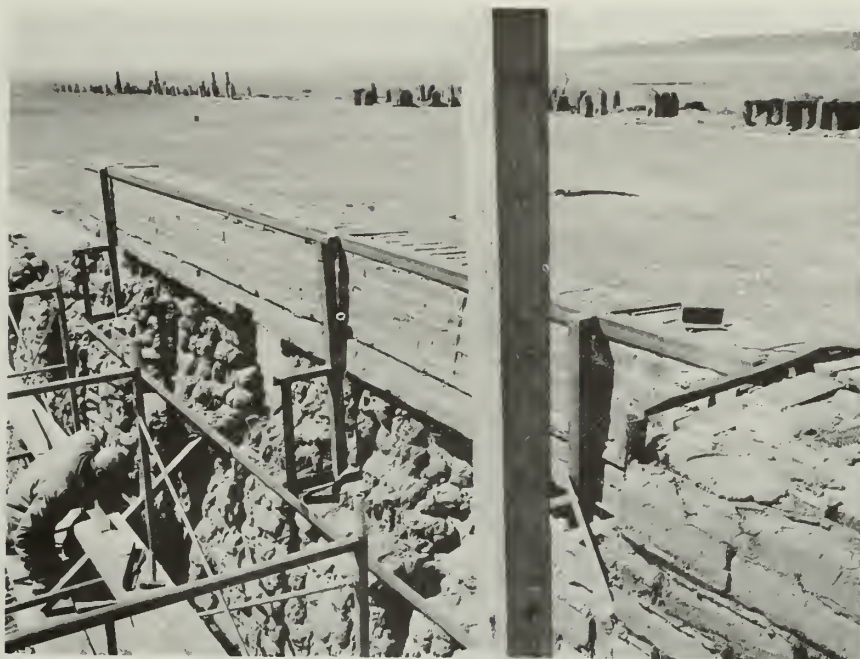
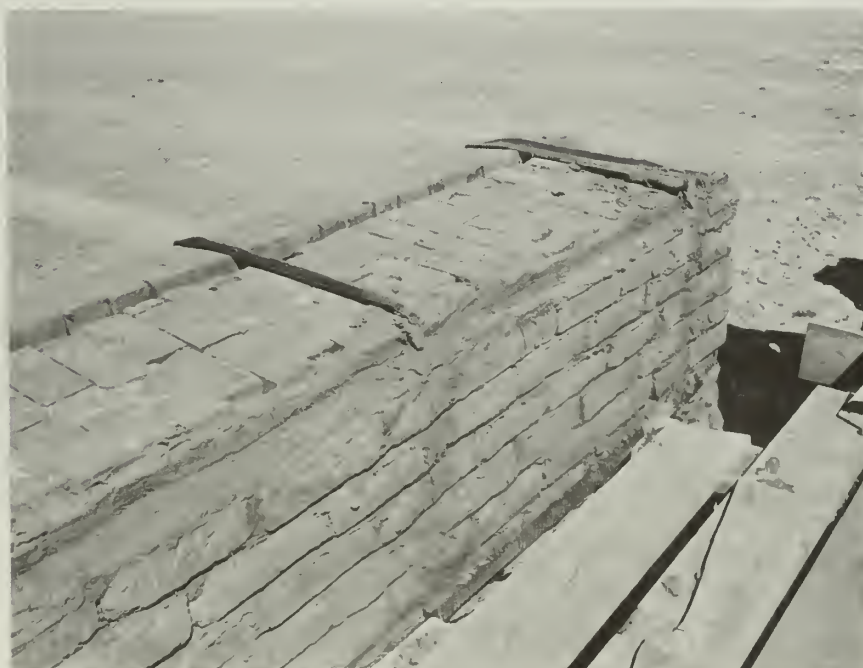
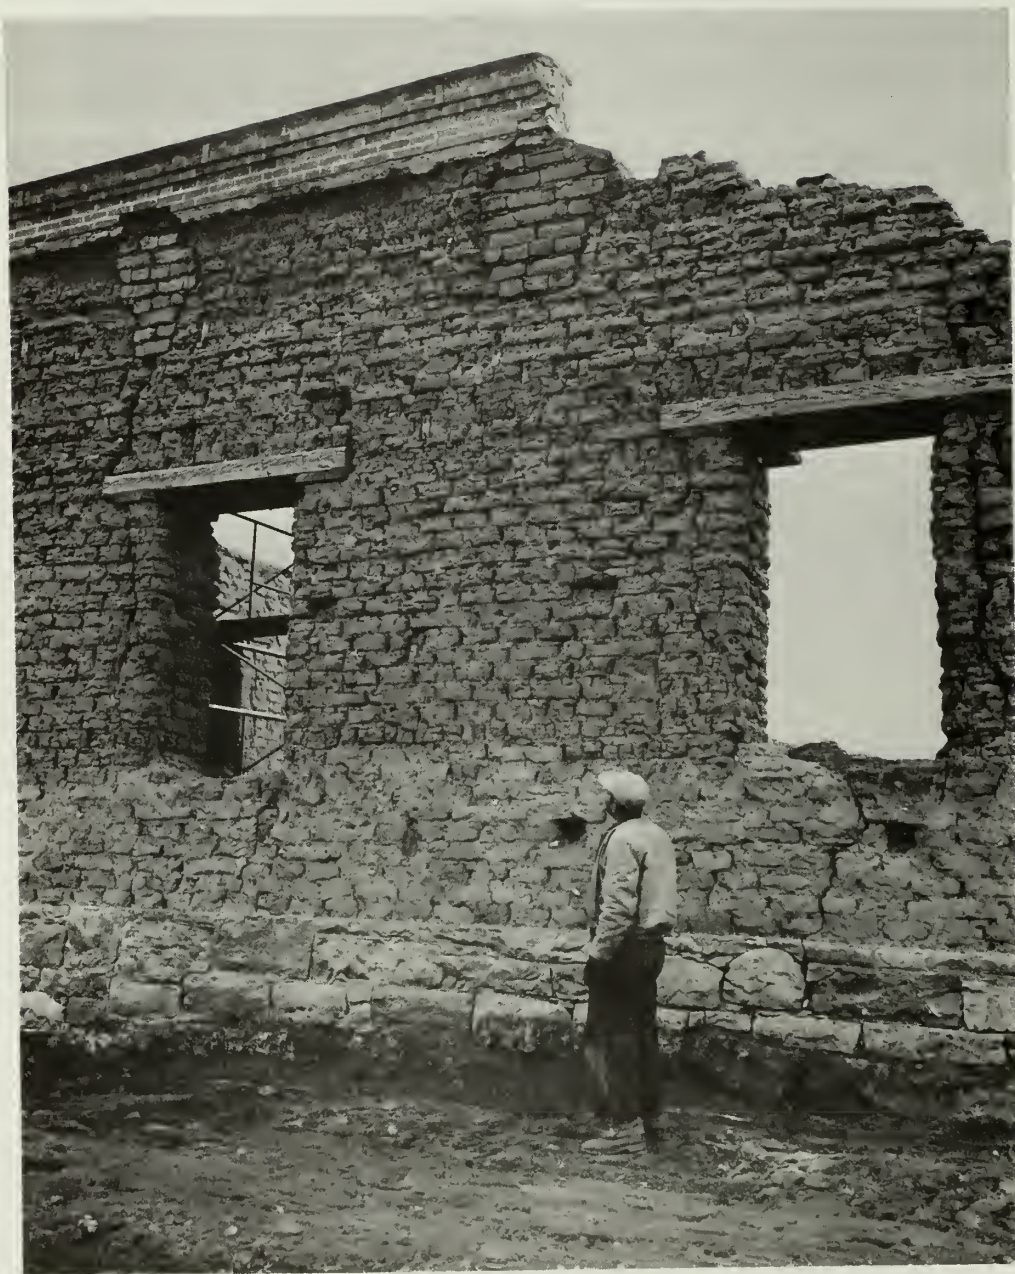
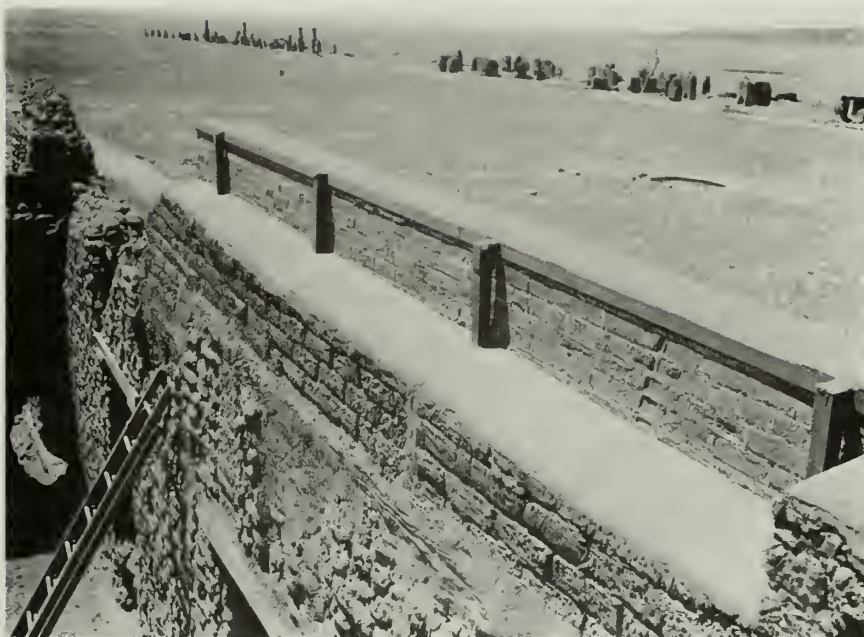
FIGURE 66. Building 3-440, coping on west wall, during stabilization, Fort Union National Monument.

FIGURE 67. Building 3-440, coping on west wall, during stabilization. Fort Union National Monument.

FIGURE 68. Building 3-440, coping on west wall, during stabilization. Fort Union National Monument.

FIGURE 69. Building 3-440, west wall and coping, during stabilization. Fort Union National Monument.

FIGURE 70. Building 3-440, south half of coping on west wall, during stabilization. Fort Union National Monument.

The top of the wall under the brick veneer cap was almost completely eroded out. The area was cleaned of loose material, squared up and lined with metal lath. It was then rebuilt with soil-cement brick to provide a solid wall between the vertical members and the heavy, solid coping. There are no free-standing (and thus visible) steel members in this part of the wall, and thus maximum rigidity was provided.

solid brick coping which is present now only on the west side of the wall. The other is immediately below and supports the horizontal veneer of brick which forms the top of this half of the coping, and which extends across the top to the east side of the wall. From the rigid framework on the east side of the wall, 1/8" x 2" modified angle-iron "hooks" extend across the top of the coping and down the west side about 7". These serve to hold the coping in place by preventing it from leaning outward at the top. To prevent the coping from dropping through collapse of the underlying adobe, only an edge of which supports the coping, a 1/8" x 2" angle-iron member was placed horizontally beneath the coping to provide support. It is secured to the framework on the opposite side of the wall by short lengths of 1/2" reinforcing rod, welded in place at each end. The remainder of this half of the framework is secured in a similar manner: an average of 3 short sections of 1/2" reinforcing rod for each vertical member penetrate the wall through drilled holes, and are welded to 6'-long strips of 1/8" x 2" strap iron sunk into the west side of the wall and to the vertical members in the east side.

The south half of the coping is more massive in construction than the north half, and there is no veneer or brick over the inner (east) portion of the adobe wall. Although the method of securing the coping at the top of the angle-iron framework is similar to that used to support the north half of the coping, more rigid construction was necessary because the vertical supports are free-standing for the top 22", approximately. Also, these top sections are offset to the west a distance of 10" from the vertical axes of the lower portions in such a manner as to place the side of the upper portions against the coping.

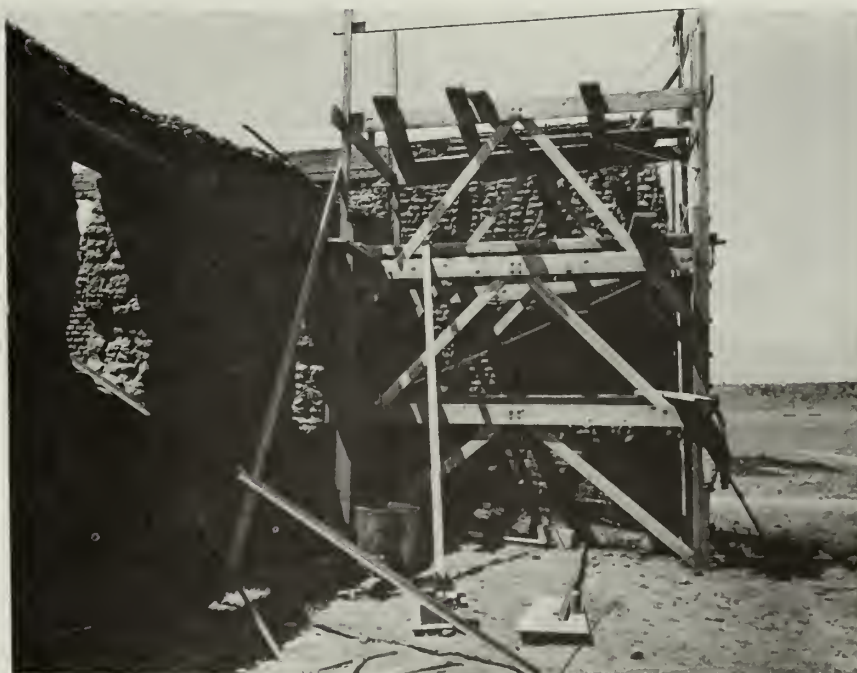
FIGURE 71. Building 3-440, northwest wing wall, during stabilization. Fort Union National Monument.

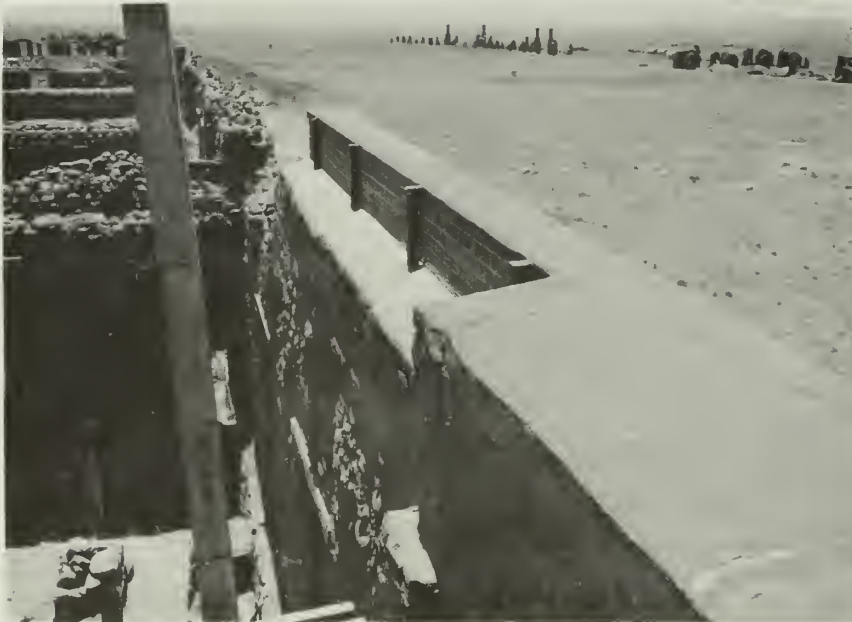
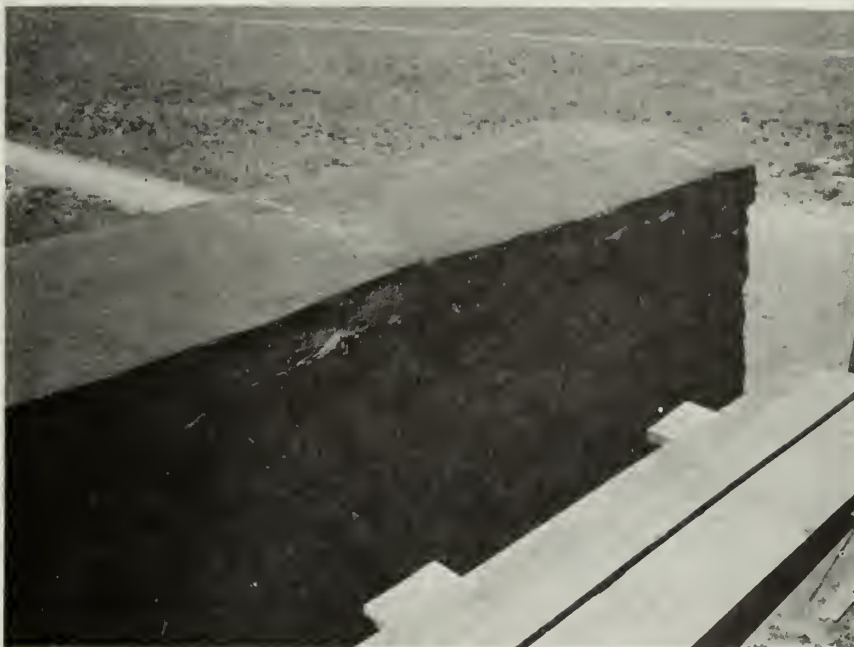
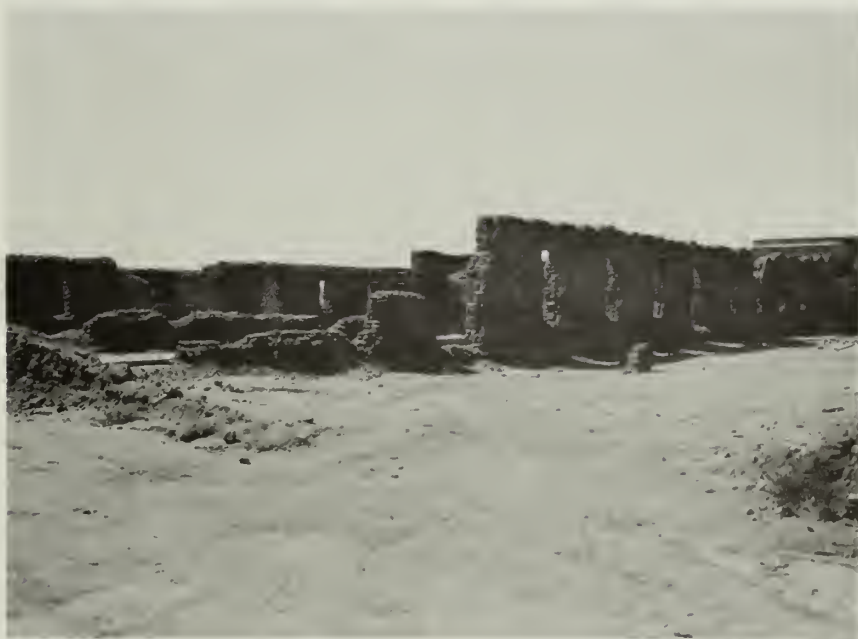
FIGURE 72. Building 3-440, coping on west wall, after stabilization. Fort Union National Monument.

FIGURE 73. Building 3-440, coping on west wall, after stabilization. Fort Union National Monument.

FIGURE 74. Building 3-440, from the northeast, after stabilization. Fort Union National Monument.

thick was placed over the top of the whole coping. The cap extends down over both edges the thickness of one brick. This extension was possible because the width of the top course of brick is less than that of the next-to-top course. When dry, the cement was painted with burnt sienna and raw umber in Exterior Stucco Finish (adobe) to render the cap less obvious.

To provide a better bond between metal, concrete and soil-cement all the angle-iron which was to be enclosed by the rebuilt portions of the wall or by refilling of the channels was first covered with metal lath. (Exposed sections of angle-iron were painted with red lead darkened with burnt sienna and raw umber.) Then all channels in the adobe wall were filled with colored soil-cement.

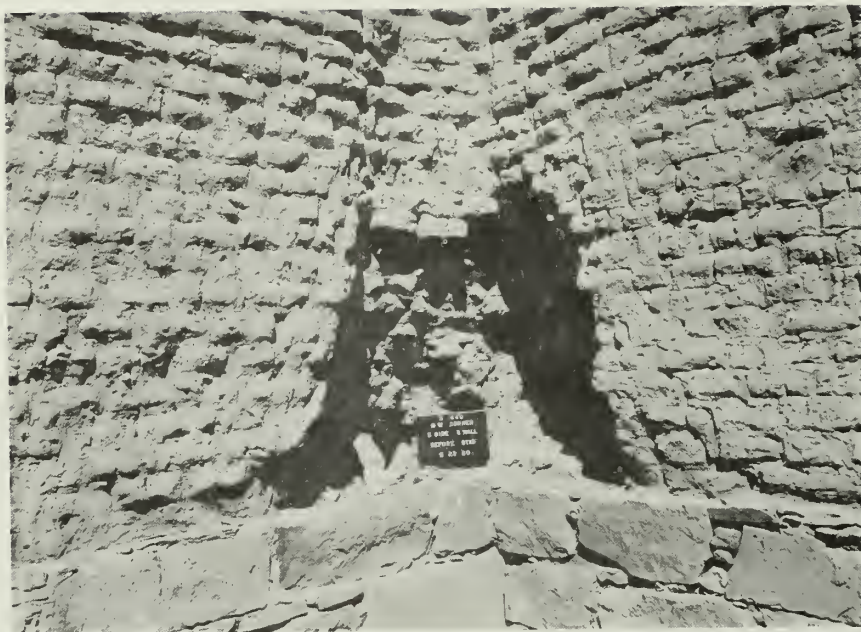
FIGURE 75. Building 3-440, southwest corner, before stabilization. Fort Union National Monument.

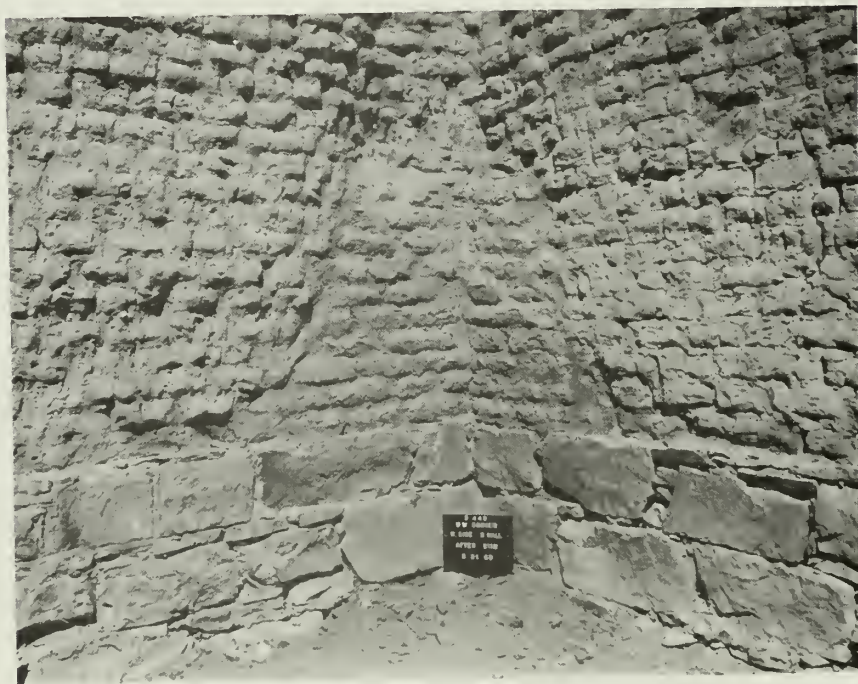
FIGURE 76. Building 3-440, southwest corner, after stabilization. Fort Union National Monument.

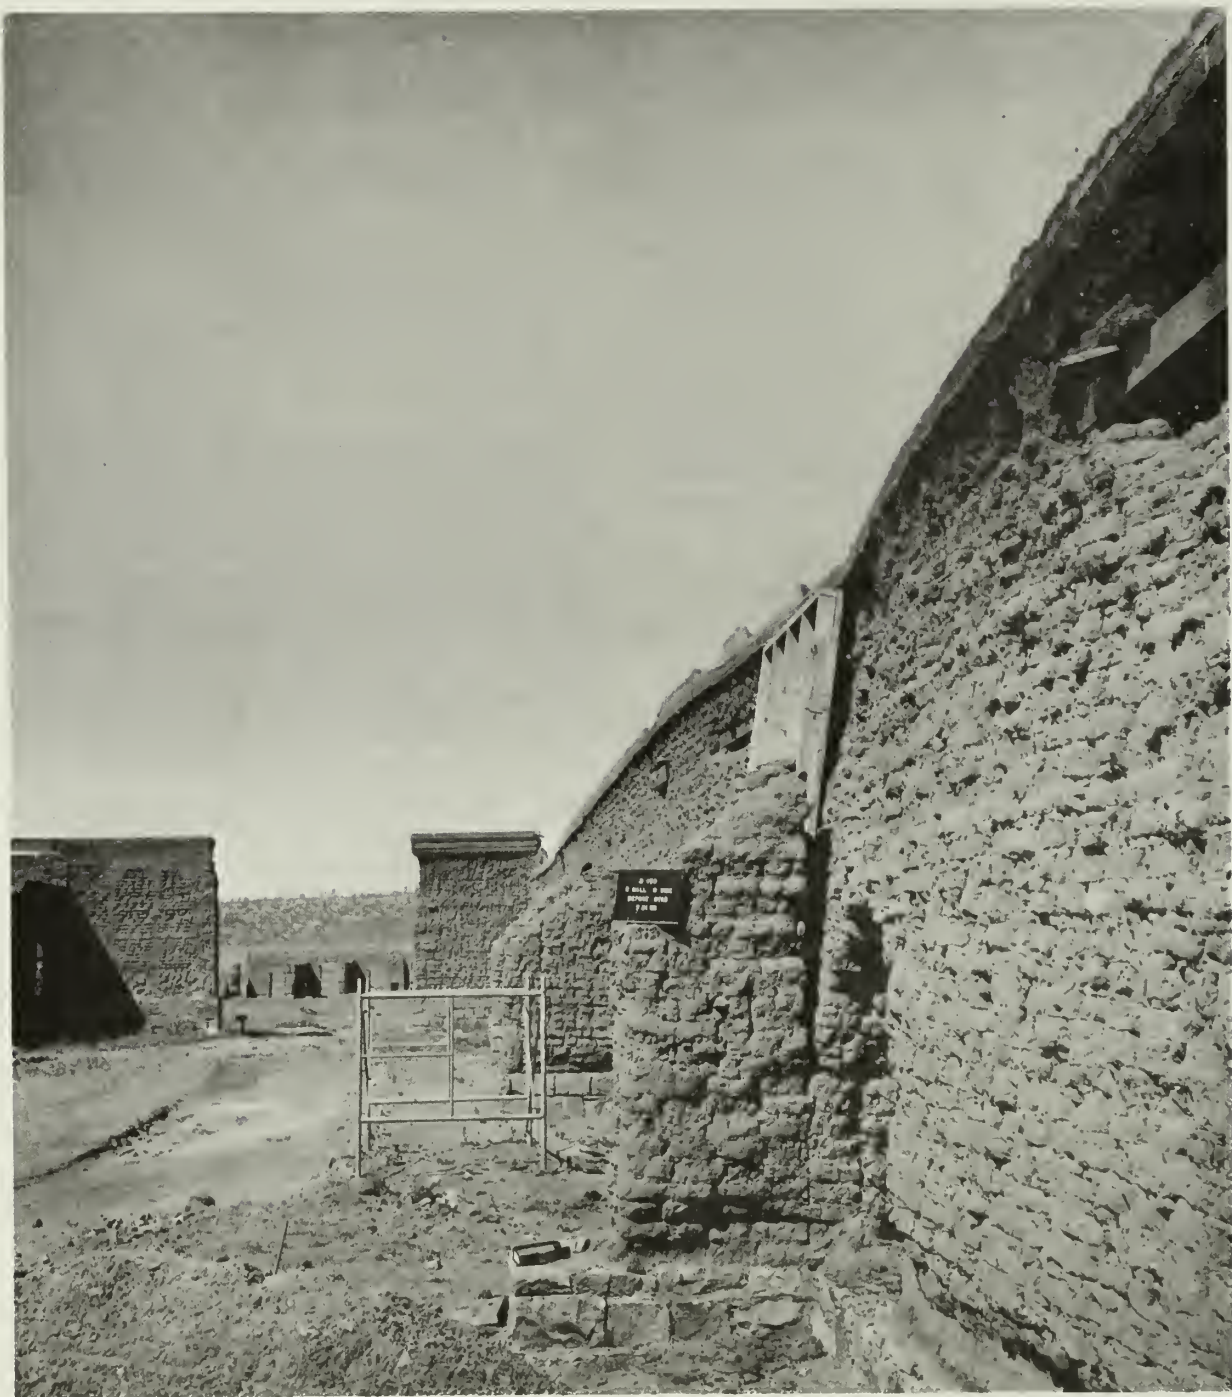
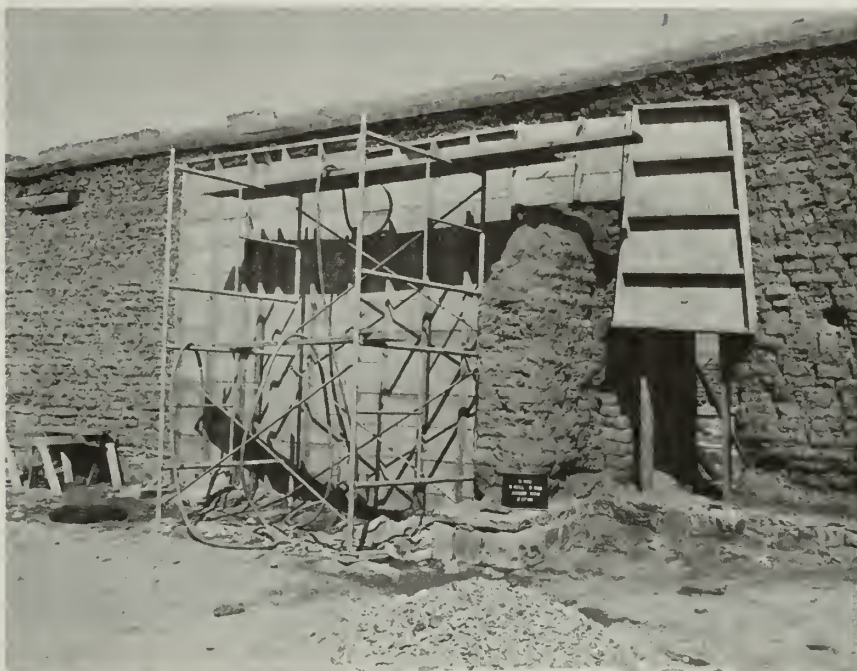
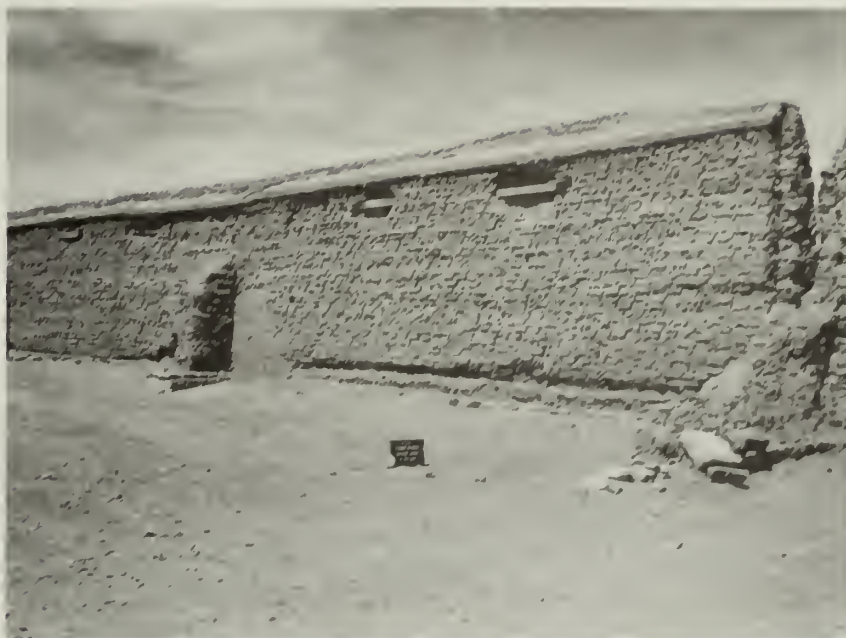
Condition on date work started. Masonry: *Massive south wall bulging northward. Only extreme west end of north wall standing. East and west walls in good condition but all walls needed capping to prevent further deterioration from penetration of moisture. Small north wall section leaning northward several inches out of plumb.*

FIGURE 77. Building 3-450, Room 451, south side of south wall, before stabilization. Fort Union National Monument.

FIGURE 78. Building 3-450, Room 451, south side of south wall, during stabilization. Fort Union National Monument.

FIGURE 81. Building 3-450, Room 451, south side of south wall, after stabilization. Fort Union National Monument.

Materials, construction, and technique in making repairs or accomplishing job: *South wall: A portion of the south wall was realigned in order to prevent collapse. The section, near the east end of the wall, bowed to the north about 12" at the top. Four wooden forms were completed and put in place on the bulge, two on either side of the wall. They were lined with asphalt roofing felt, wired together through the wall with No. 9 black wire, and then the space between form and wall was packed with damp sand. Two mine roof jacks and one heavy-duty jack were used to move the wall. The jacks push against the wall by means of long sections of 2" pipe (mine roof jacks) and 4" x 4" timber (truck jack). After pushing the wall into plumb the jacketing was removed from both sides of the wall and stabilization was begun by placing six upright steel members, and two horizontal members of the same material, with a steel strap along the bottom seated upon the stone foundation. The wall's brick coping is being held in place by seven steel rods looped about it and welded to the steel members on the wall's north side. The steel on the north side of the wall is secured by rods through the wall that are held in place by short steel straps. A hole in the wall was filled with regular adobes, cracks were grouted, steel was covered with adobe, the coping was secured, and adobes were laid along the top of the wall preliminary to capping.*

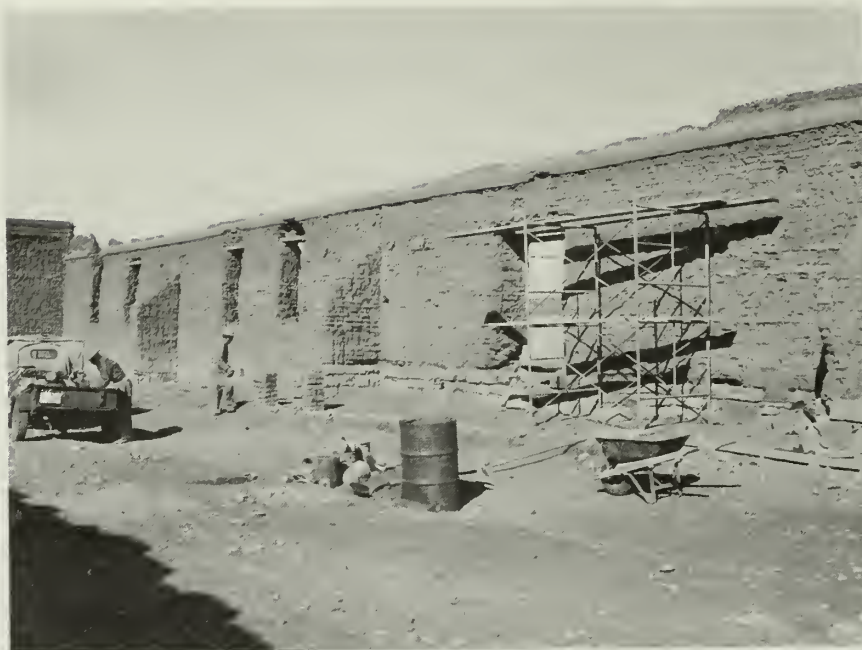
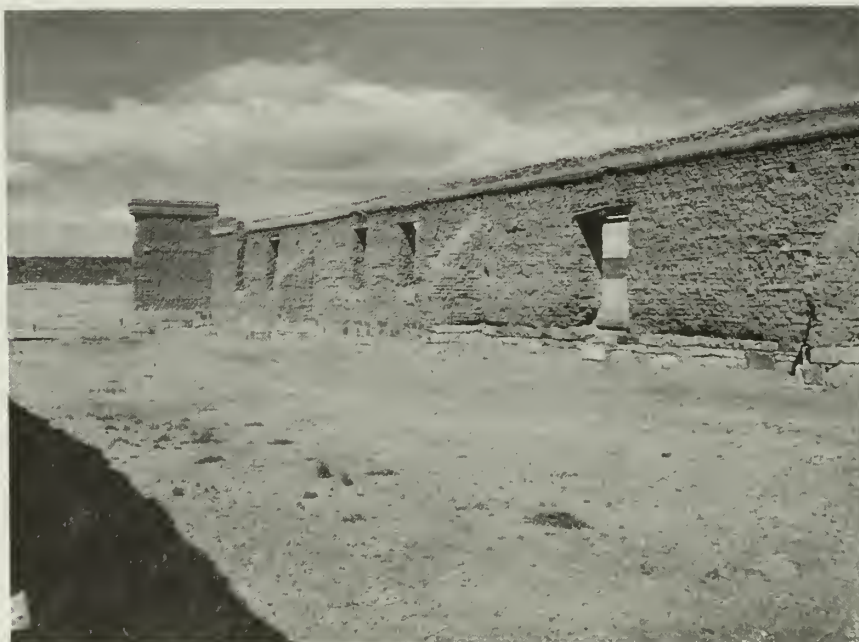
FIGURE 79. Building 3-450, Room 452, south side of south wall, before stabilization. Fort Union National Monument.

FIGURE 80. Building 3-450, Room 452, south side of south wall, after stabilization. Fort Union National Monument.

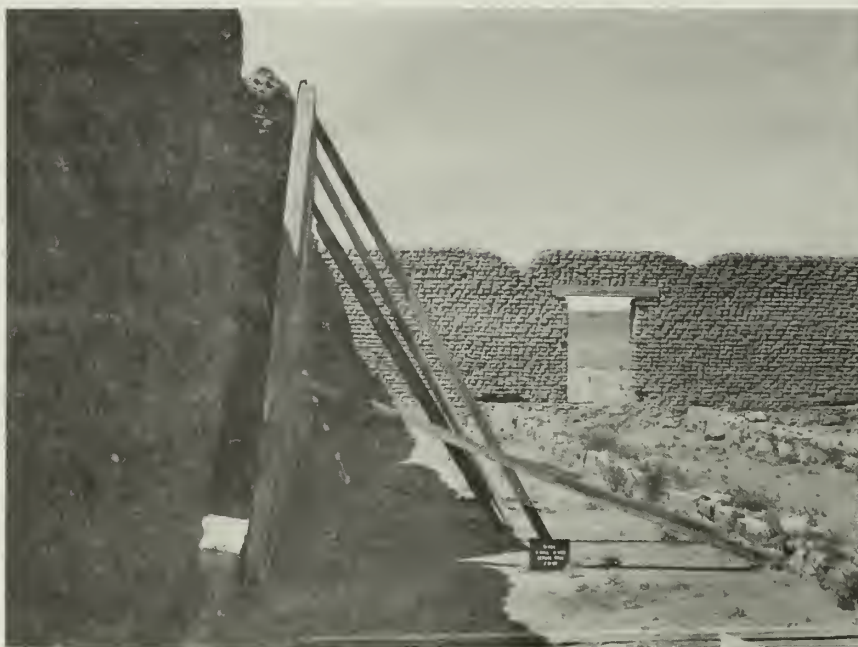
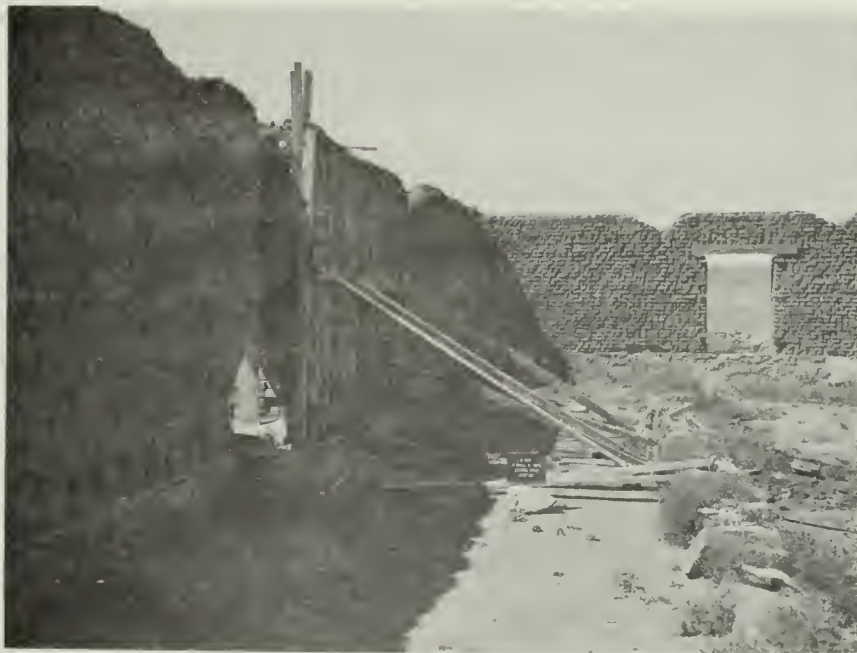
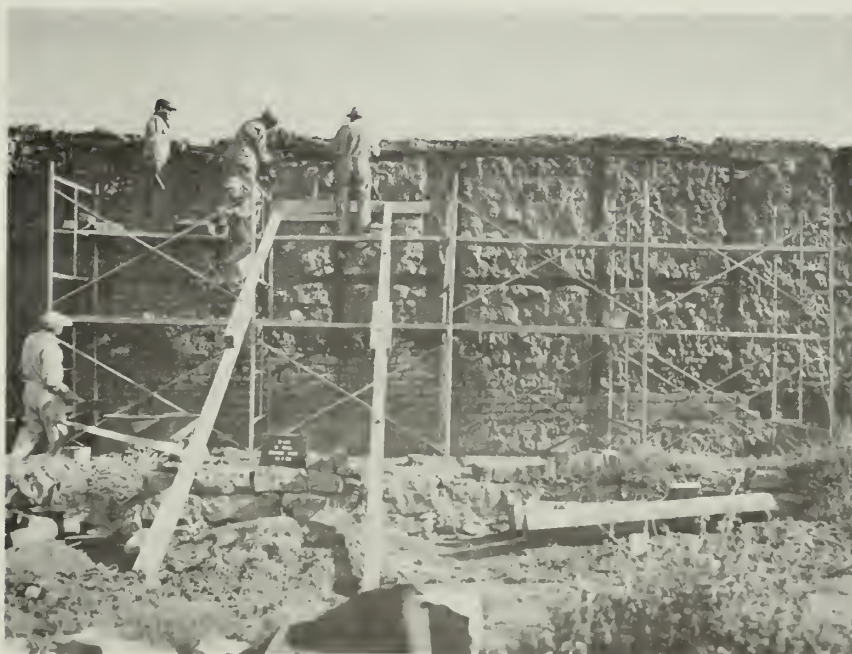
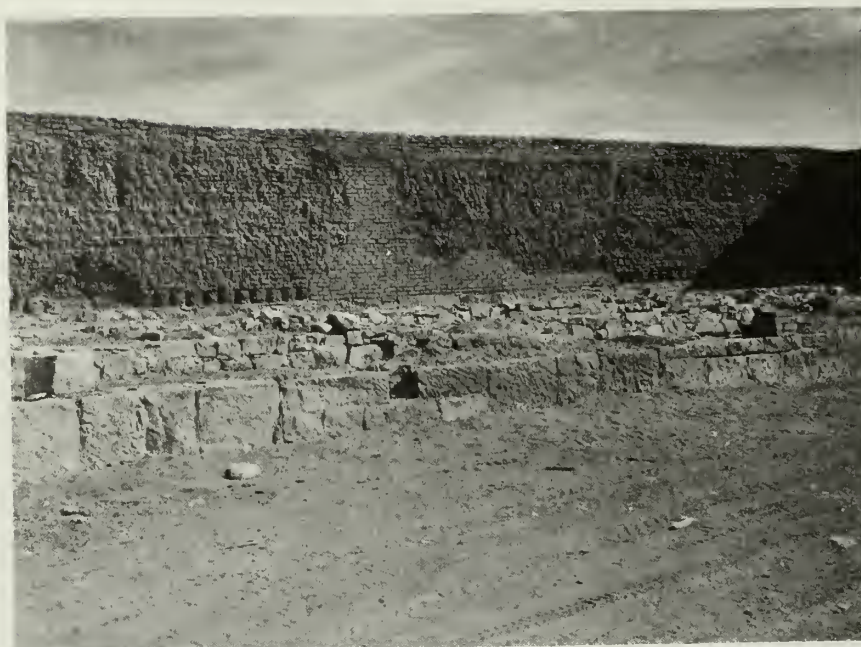
FIGURE 82. Building 3-450, Room 451, north side of south wall, before stabilization. Fort Union National Monument.

FIGURE 83. Building 3-450, Room 451, north side of south wall, during stabilization. Fort Union National Monument.

FIGURE 84. Building 3-450, Room 451, north side of south wall, during stabilization. Fort Union National Monument.

FIGURE 85. Building 3-450, Room 451, north side of south wall, after stabilization. Fort Union National Monument.

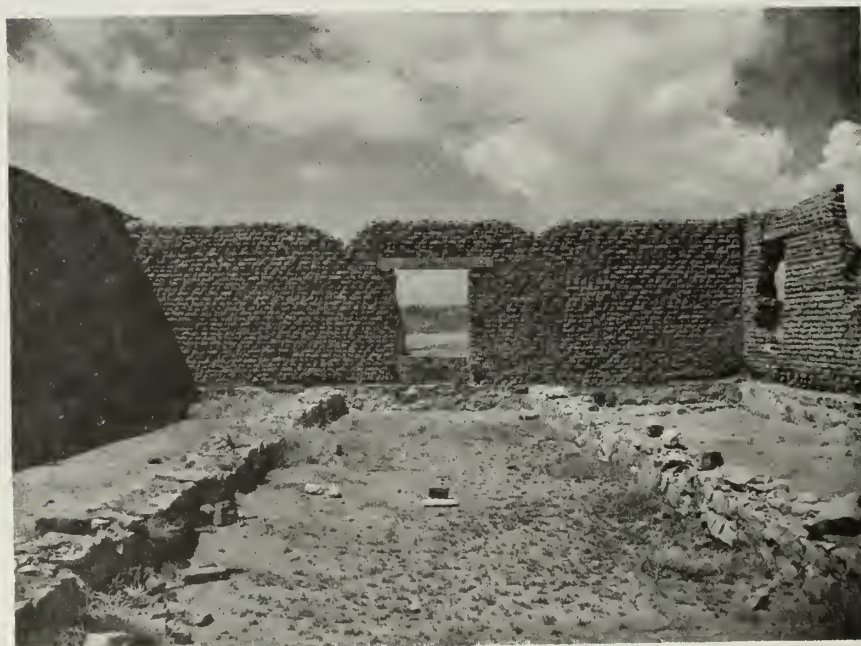
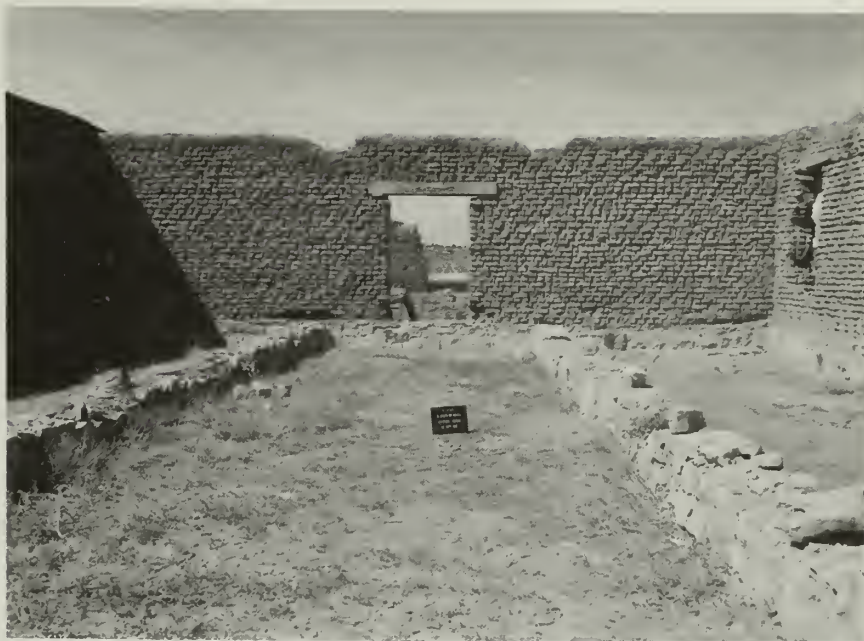
FIGURE 86. Building 3-450, Room 451, east side of west wall, before stabilization. Fort Union National Monument.

FIGURE 87. Building 3-450, Room 451, east side of west wall, after stabilization. Fort Union National Monument.
